Level II With Site Visit Reserve Study Report For Fiscal Year Beginning January 1, 2024

The Mediterranean Villas

Pasco, WA
April 24, 2023

Reserve Study Summary for The Mediterranean Villas

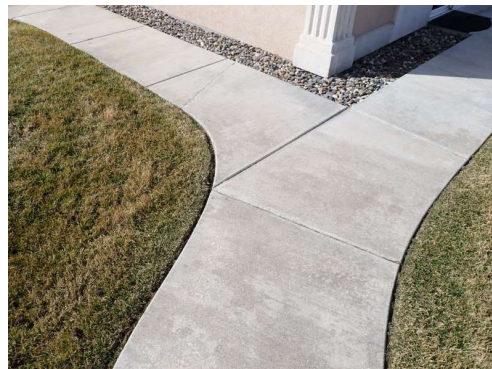
Concrete - Repair Allotment - 2028

Component History: No history reported, an estimated in-service date of 2023 has been used as no repair needs reported

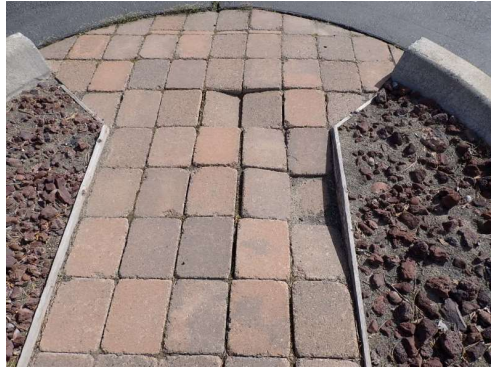
Pavers - Repair

Location: Adjacent to parking area within Phase 1

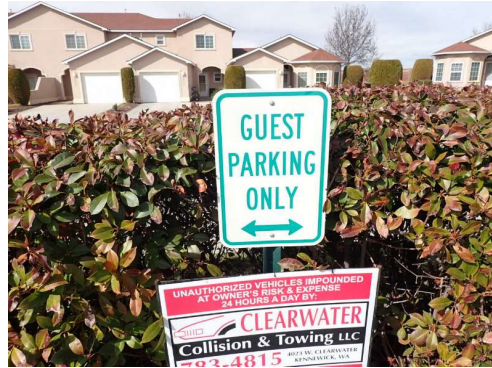
Metal Signs - Replace

Location: Scattered common area locations
