Level II With Site Visit Reserve Study Report For Fiscal Year Beginning January 1, 2024

The Mediterranean Villas

Pasco, WA
April 24, 2023

Reserve Study Summary for The Mediterranean Villas

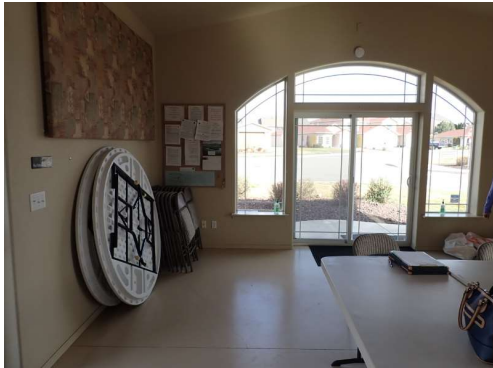
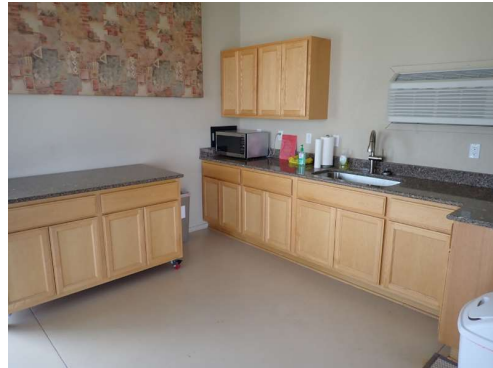
Palazzo Interior - Renovate - 2030

Palazzo consisted of one main room with a small kitchenette and basic restroom. Regular cycles of interior renovation are recommended due to the high visibility of this common element. Projects may include kitchen renovation, appliances, restroom renovation, plumbing fixtures, flooring, interior paint, interior lighting, hot water heater replacement, HVAC equipment replacement, etc. Cost can vary widely based on scope of work therefore a middle range allowance has been included for the purposes of this report. Handle smaller projects through operating budget on an as-needed basis in between larger refurbishing cycles.

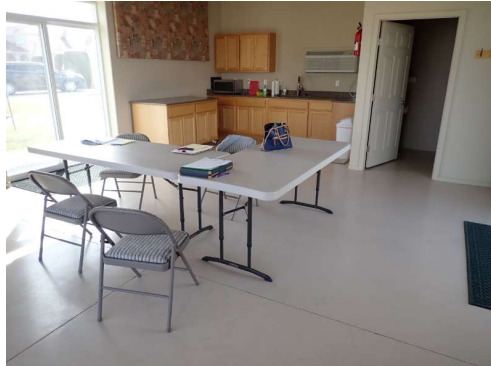
Palazzo Furniture - Replace

Cost to replace Palazzo furniture is projected to be too small to qualify for reserves therefore replace as needed through annual operating budget.

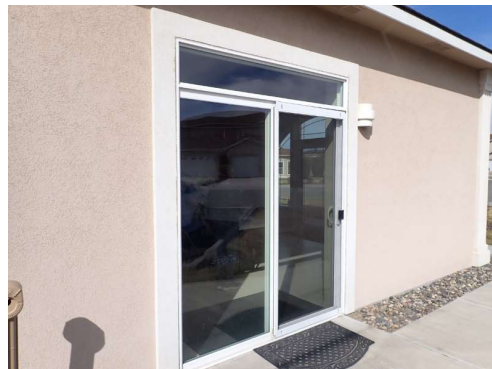
Palazzo Windows/Doors - Replace - 2030

The average useful life of vinyl windows and doors is approximately 25-30 years although a high quality window may last longer. Windows installed by the builder are typically considered builder grade and have a useful life which is on the shorter end of the scale. Signs of vinyl window failure include fogging of the glass, cracks/separation of the miter joints at the window frame and water intrusion. Vinyl windows, particularly those in areas of high UV exposure, expand and contract which can aid in failure of the window. Proper installation of windows using correct flashings and sealants is critical to window performance and preventing damage and/or decay of the siding and framing around the window. In order to achieve proper weatherproofing techniques the siding must be removed around the window for replacement; exercise caution if a vendor advises that a window can be replaced without removal of the siding. Do not caulk flashing above window and/or window weep holes.

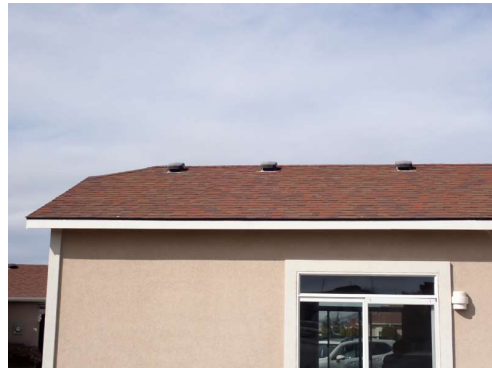
Palazzo/Pavilion Roof - Replace

The average useful life of a composition shingle roof can vary based on the quality of installation, quality of shingle product, underlayment, flashings and general site conditions (exposure to high winds, etc.). The useful life above is for financial planning purposes; have your roof evaluated by your roofing vendor or an independent roofing consultant as the roof nears the end of its useful life to narrow down an exact time frame for replacement.

As routine maintenance, have your roof inspected regularly by a qualified roofing contractor. Inspection schedules typically include in the spring, fall, and following significant wind events. Signs of roof failure include loss of granulation (typically identified by granule build up in gutters), curling and/or buckling of shingles, and loss of shingles during weather events. Clean roof regularly to remove any tree debris and treat for moss as needed.

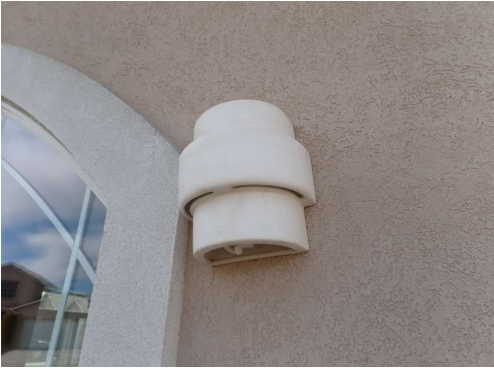
Palazzo Exterior Lighting - Replace

Cost to replace this small quantity of lighting is projected to be too inexpensive to qualify for reserve funding therefore replace as needed through annual operating budget.

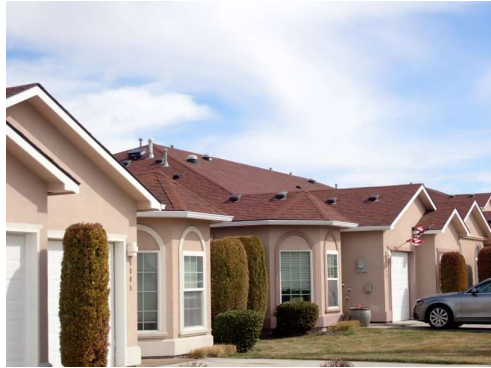
Unit Roofs - Replace

Documentation provided by client indicates that roof maintenance, repair and replacement is the responsibility of the unit owner therefore no reserve funding included.

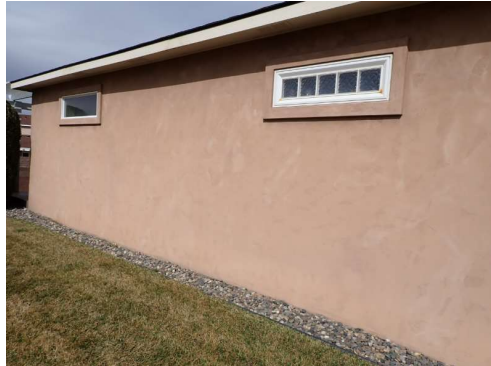
Stucco Siding - Replace

When properly installed, well maintained stucco has a useful life which exceeds the scope of this report therefore there is no predictable basis to expect wide scale replacement of stucco siding and no reserve funding is included. See separate component for periodic cycles of repair and recoating of stucco (client reports that minor repairs are handled through annual operating budget).

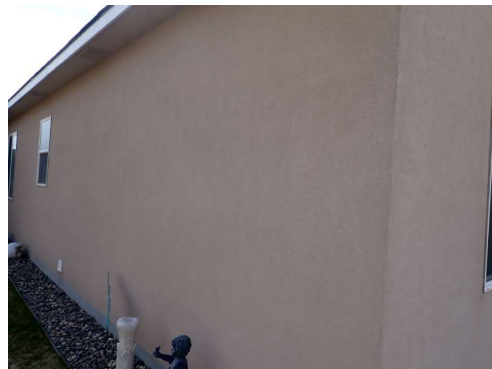
Stucco Siding - Repair/Recoat Phase 1 - 2032

While stucco is a naturally waterproof product, it is recommended to plan for periodic cycles of cleaning, repairing and recoating stucco at 15-20 year intervals. In addition to the aesthetic benefit of a fresh coat of paint, recoating stucco helps disguise areas of repair which will inevitably occur at stucco.

If your building is experiencing water intrusion issues, we strongly recommend performing a building envelope investigation (see separate component) prior to recoating stucco to ensure that the coating product used is most appropriate for your building.

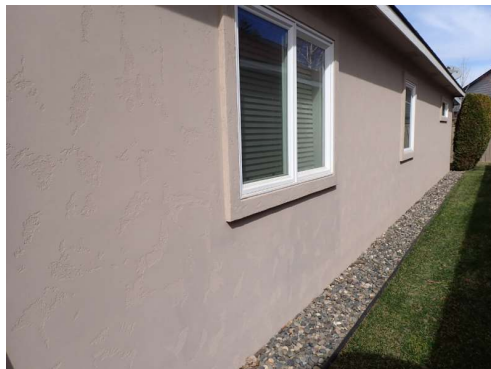
Stucco Siding - Repair/Recoat Phase 2 - 2032

While stucco is a naturally waterproof product, it is recommended to plan for periodic cycles of cleaning, repairing and recoating stucco at 15-20 year intervals. In addition to the aesthetic benefit of a fresh coat of paint, recoating stucco helps disguise areas of repair which will inevitably occur at stucco.

If your building is experiencing water intrusion issues, we strongly recommend performing a building envelope investigation (see separate component) prior to recoating stucco to ensure that the coating product used is most appropriate for your building.

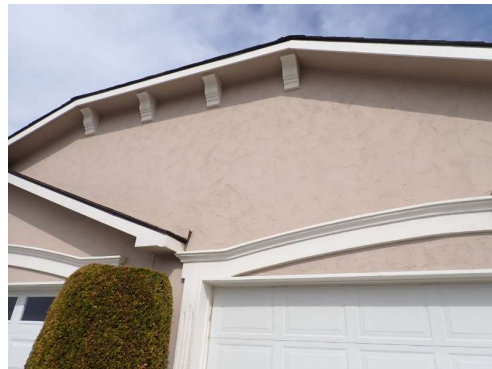
Stucco Siding - Repair/Recoat Phase 3 (a) - 2039

While stucco is a naturally waterproof product, it is recommended to plan for periodic cycles of cleaning, repairing and recoating stucco at 15-20 year intervals. In addition to the aesthetic benefit of a fresh coat of paint, recoating stucco helps disguise areas of repair which will inevitably occur at stucco.

If your building is experiencing water intrusion issues, we strongly recommend performing a building envelope investigation (see separate component) prior to recoating stucco to ensure that the coating product used is most appropriate for your building.

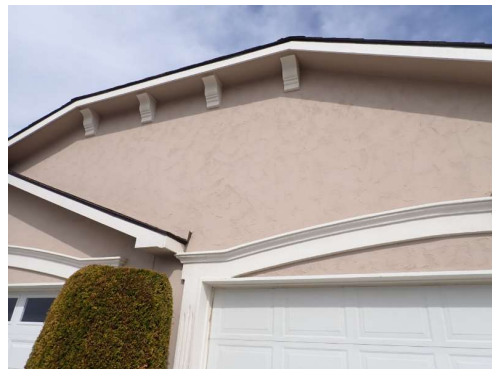
Stucco Siding - Repair/Recoat Phase 3 (b) - 2031

While stucco is a naturally waterproof product, it is recommended to plan for periodic cycles of cleaning, repairing and recoating stucco at 15-20 year intervals. In addition to the aesthetic benefit of a fresh coat of paint, recoating stucco helps disguise areas of repair which will inevitably occur at stucco.

If your building is experiencing water intrusion issues, we strongly recommend performing a building envelope investigation (see separate component) prior to recoating stucco to ensure that the coating product used is most appropriate for your building.

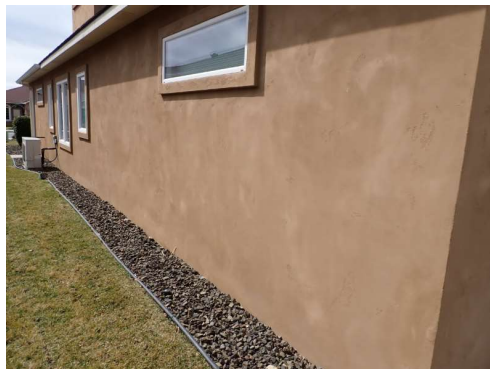
Stucco Siding - Repair/Recoat Phase 4 - 2034

While stucco is a naturally waterproof product, it is recommended to plan for periodic cycles of cleaning, repairing and recoating stucco at 15-20 year intervals. In addition to the aesthetic benefit of a fresh coat of paint, recoating stucco helps disguise areas of repair which will inevitably occur at stucco.

If your building is experiencing water intrusion issues, we strongly recommend performing a building envelope investigation (see separate component) prior to recoating stucco to ensure that the coating product used is most appropriate for your building.

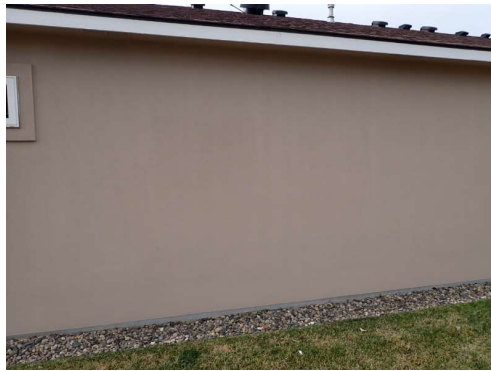
Stucco Siding - Repair/Recoat Phase 5 - 2035

While stucco is a naturally waterproof product, it is recommended to plan for periodic cycles of cleaning, repairing and recoating stucco at 15-20 year intervals. In addition to the aesthetic benefit of a fresh coat of paint, recoating stucco helps disguise areas of repair which will inevitably occur at stucco.

If your building is experiencing water intrusion issues, we strongly recommend performing a building envelope investigation (see separate component) prior to recoating stucco to ensure that the coating product used is most appropriate for your building.

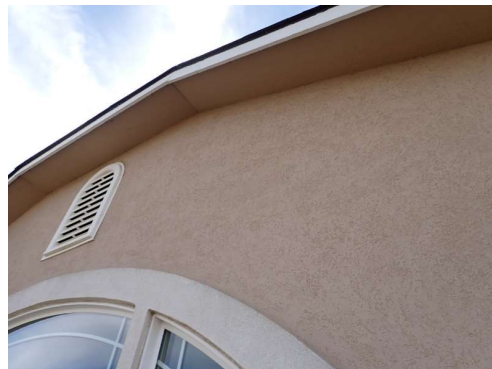
Stucco Siding - Repair/Recoat Palazzo/Pavilion - 2032

While stucco is a naturally waterproof product, it is recommended to plan for periodic cycles of cleaning, repairing and recoating stucco at 15-20 year intervals. In addition to the aesthetic benefit of a fresh coat of paint, recoating stucco helps disguise areas of repair which will inevitably occur at stucco.

If your building is experiencing water intrusion issues, we strongly recommend performing a building envelope investigation (see separate component) prior to recoating stucco to ensure that the coating product used is most appropriate for your building.

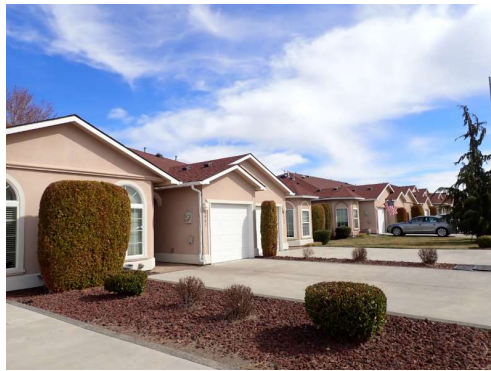
Building Envelope Investigation - 2033

A reserve study site visit conducts a limited visual review for budgetary purposes only and does not include any invasive testing or structural evaluation. As a result, periodic building envelope investigations are strongly recommended to ensure that building envelope components are performing as designed and to help identify the potential for hidden damages early, thus reducing the risk of unanticipated repair costs. When performed prior to exterior work such as siding and window replacement, a building envelope investigation also helps determine the extent of hidden damages, if any, so the association is not surprised by a significant increase in costs after the project starts. Building envelope investigations should be performed after being turned over from the developer (or prior to expiration of the builder’s warranty, whichever is first), at 5-10 year intervals thereafter based on building age and individual needs, and prior to performing large exterior envelope projects. Some governing documents may require annual envelope investigations; we recommend reviewing your association’s governing documents for any requirements unique to your association.
